5101-141
Low-Cost
Solar Array Project

LSA Field Test Annual Report August 1978-August 1979

Peter Jaffe

December 15, 1979

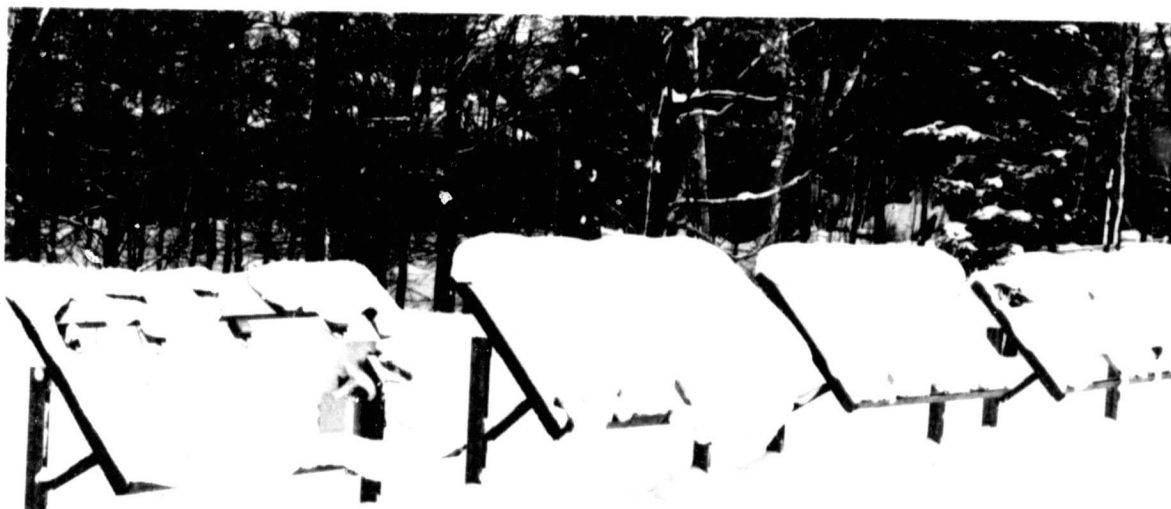
Figure 2-10. Midwest and Upper Great Lakes Sites

Houghton, Michigan (Winter of 78-79)

existing network. Figure 2-5 shows the locations of the sites, and Table 2-1 summarizes the key features. Each site has the same inventory of modules: four of each of the Block II modules.* To simulate use in the field each module is loaded with a resistor designed to force the module to operate at conditions close to peak-power. Figures 2-6 through 2-11 contain photographs of the sites by group.

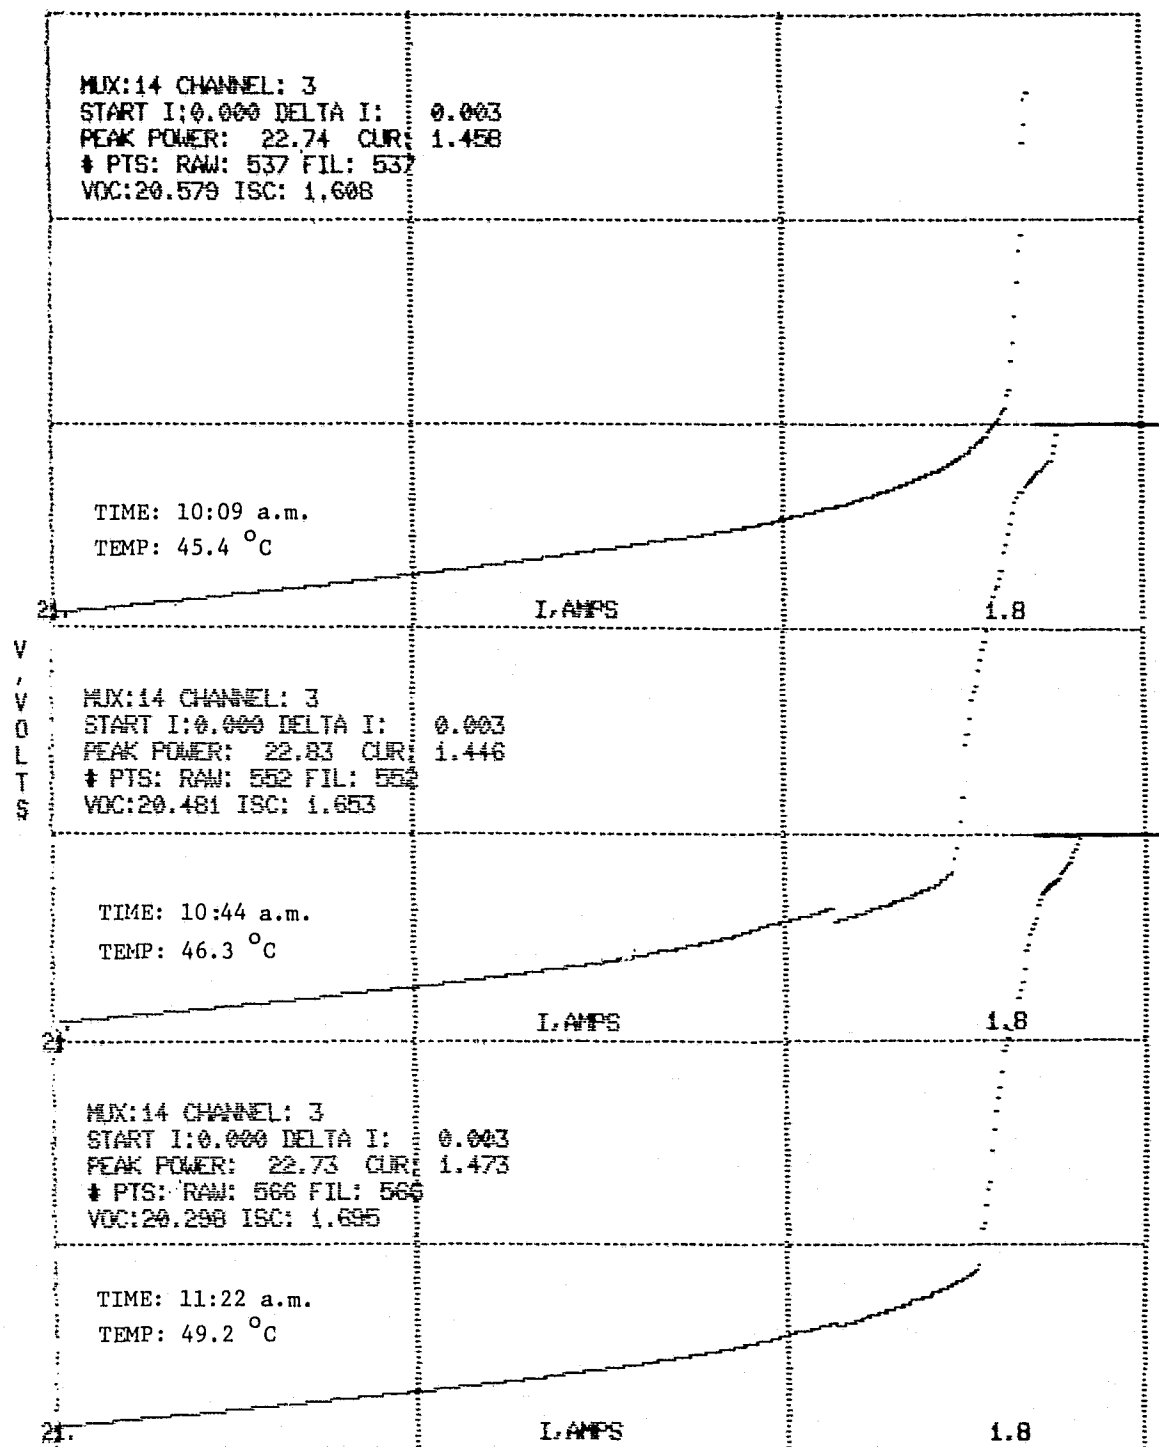
Figure 4-1. Effects of Temperature on Module 211

Module 211 was recently taken out of the field and interrogated with the LAPSS in connection with the reference cell investigation. The LAPSS data, taken at room temperature, showed the module to be in excellent condition, with no change from previous LAPSS interrogations. Visually the module looked fine also. A review of past field data revealed that the power output of the module had been down intermittently for some time. To trace the problem, data was taken in the field several times during the same day and over a period of several days. Figure 4-1 shows a sequence of I-V curves produced by the Field Test Data System on the same day. (The I-V curves are rotated 90 degrees from their normal orientation. The numbers 21 and 1.8 refer to the maximum voltage and current plot scales, respectively. The voltage (ordinate) axis of the lower curves was suppressed to condense the graph. Tick marks on the right side of the figure indicate the origin for each of the ordinate axes.) The data was taken at 10:09, 10:44 and 11:22 a.m.; the corresponding module temperatures were 45.4°C, 46.3°C and 49.2°C. As shown in the figure, at 45°C the module was functioning fine, but a degree or so later it appears badly degraded. To add to the confusion, data obtained on other days indicated that the degraded curves did not always look the same and that the onset of degradation did not always occur at the same temperature. Ambiguous data of this type is symptomatic of unstable degraded modules. It is obvious from this example that caution must be exercised when concluding that a module is either good or bad.

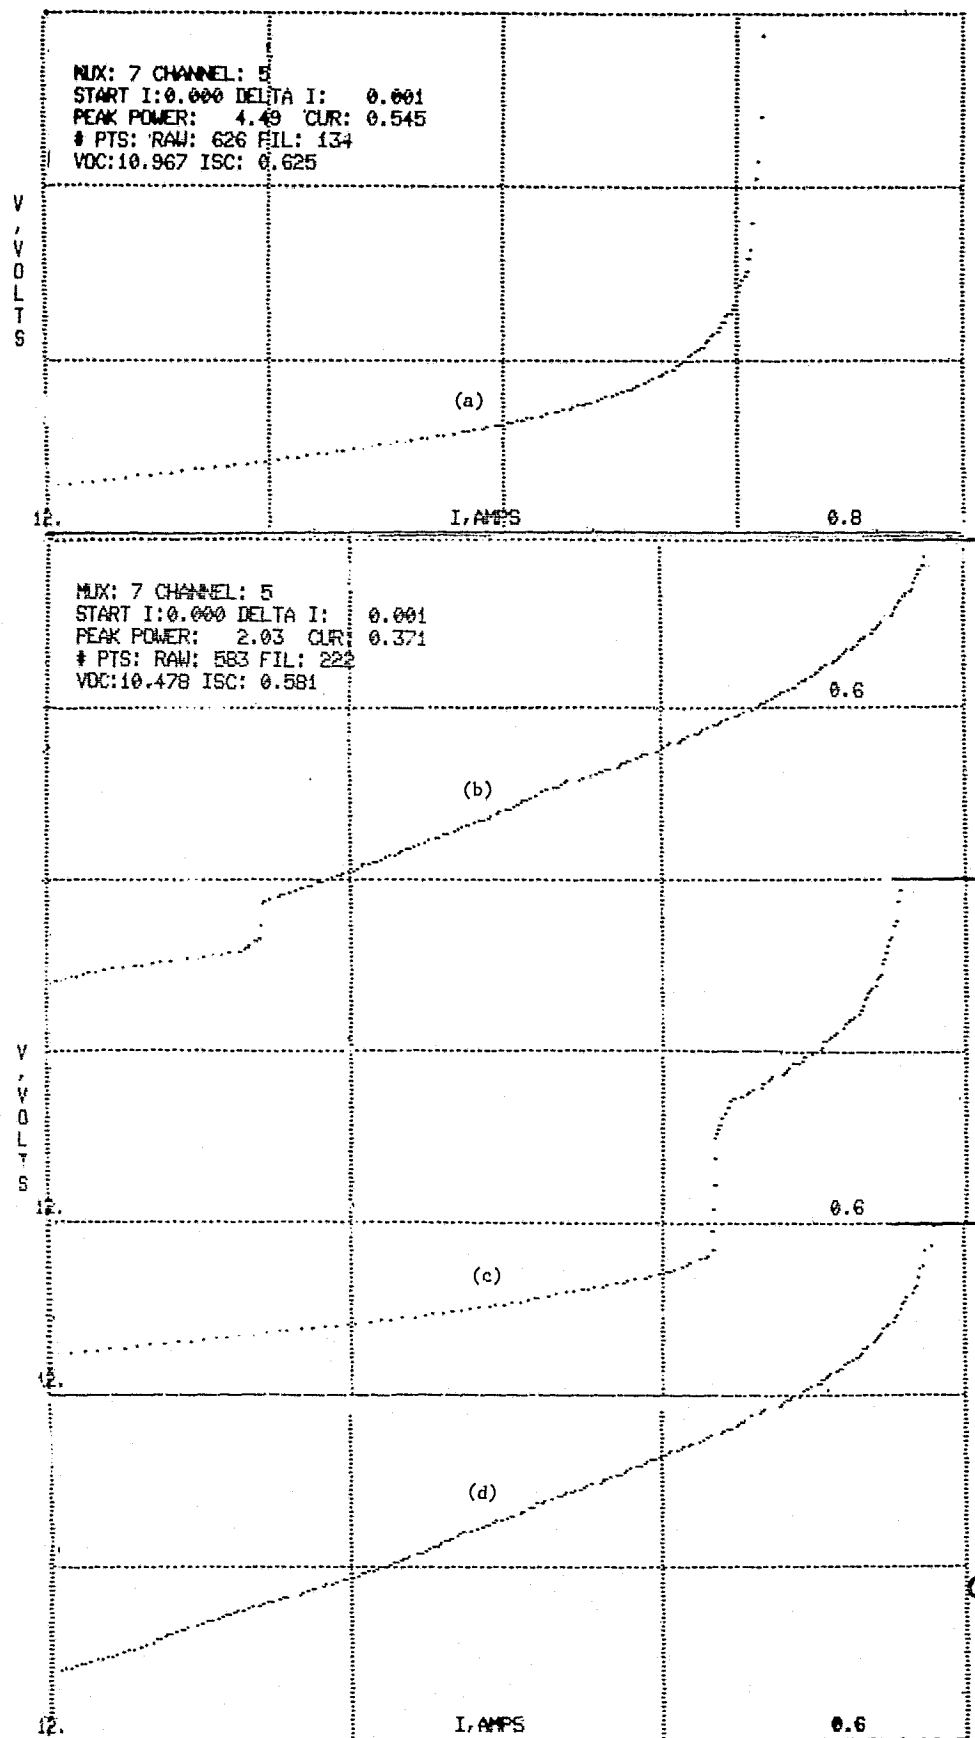
Figure 4-2. I-V History of Module 101

Case Study 1. Module 101 is a degraded module that has been under observation for a long time. A sequence depicting the evolution of its change is seen in Figure 4-2. (Tick marks on the right side of the figure indicate the origin for each of the ordinate axes.) Prior to March 2, 1979, module 101 showed no abnormalities. Within a few days after March 2 this module's normal looking I-V curve (Figure 4-2(a)) exhibited a sudden discontinuity (Figure 4-2(b)). The I-V curve continued to vary and one month later a normal I-V curve was again seen. Subsequently, other strange shapes in the curves appeared (Figure 4-2(c)) and eventually a stable but degraded condition developed (Figure 4-2(d)). Module 101 has a cracked cell which undoubtedly accounts for its degradation. Unfortunately neither the date nor the origin of the crack is known.

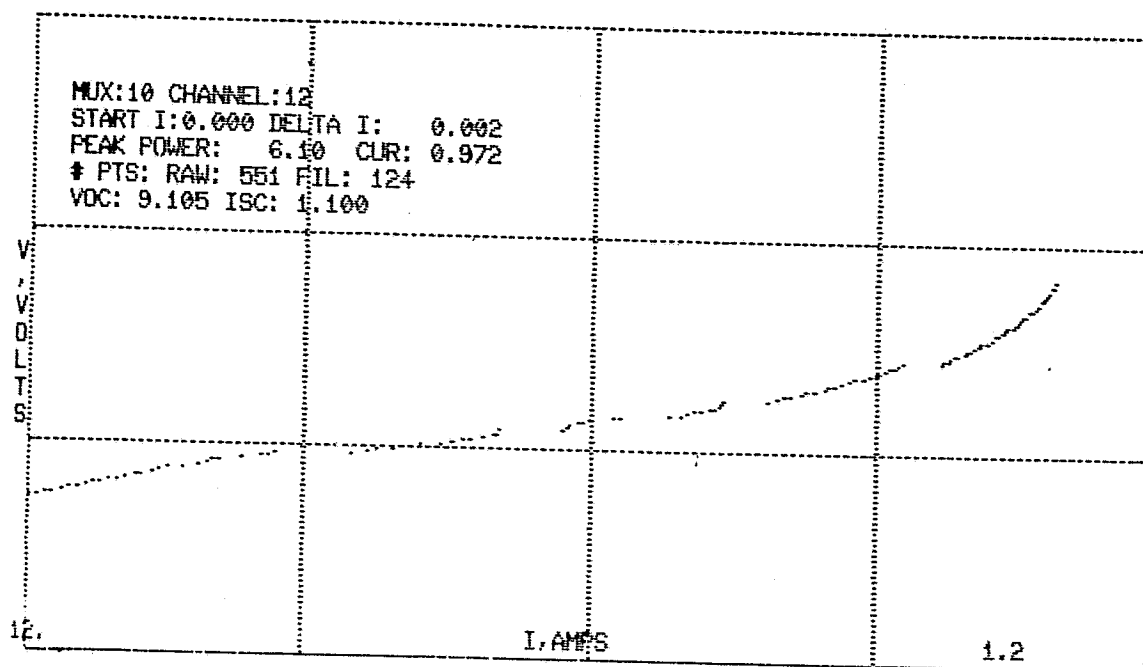
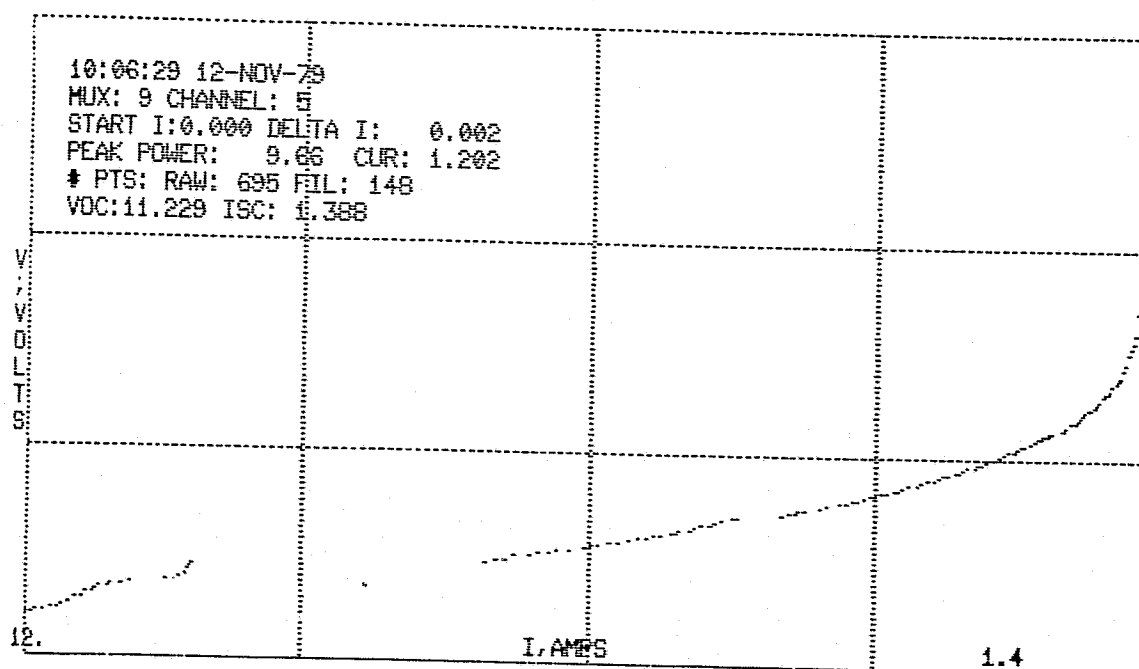
Figure 4-3. I-V Curves of Two Erratically Behaving Modules

Case Study 2. The cause of the erratic behavior of I-V curves is not always obvious nor can it be attributed to one particular mechanism. Figure 4-3 shows the I-V curves of two different degraded modules which have exhibited erratic behavior of a similar nature. Module 113 (Figure 4-3(a)) was tested at several temperatures and found to be sensitive to temperature. Since the I-V curve of module 156 (Figure 4-3(b)) resembles the curve of module 113, it is natural to assume that this module is also sensitive to temperature; however, it is not. It was discovered that when pressure was applied to the module near one of the interconnects, the voltage reading went up to the normal value. When the pressure was released the voltage dropped and fluctuated. Undoubtedly this module has a bad interconnect junction.

(a) Module 113 - Temperature Sensitive

(b) Module 156 - Pressure Sensitive

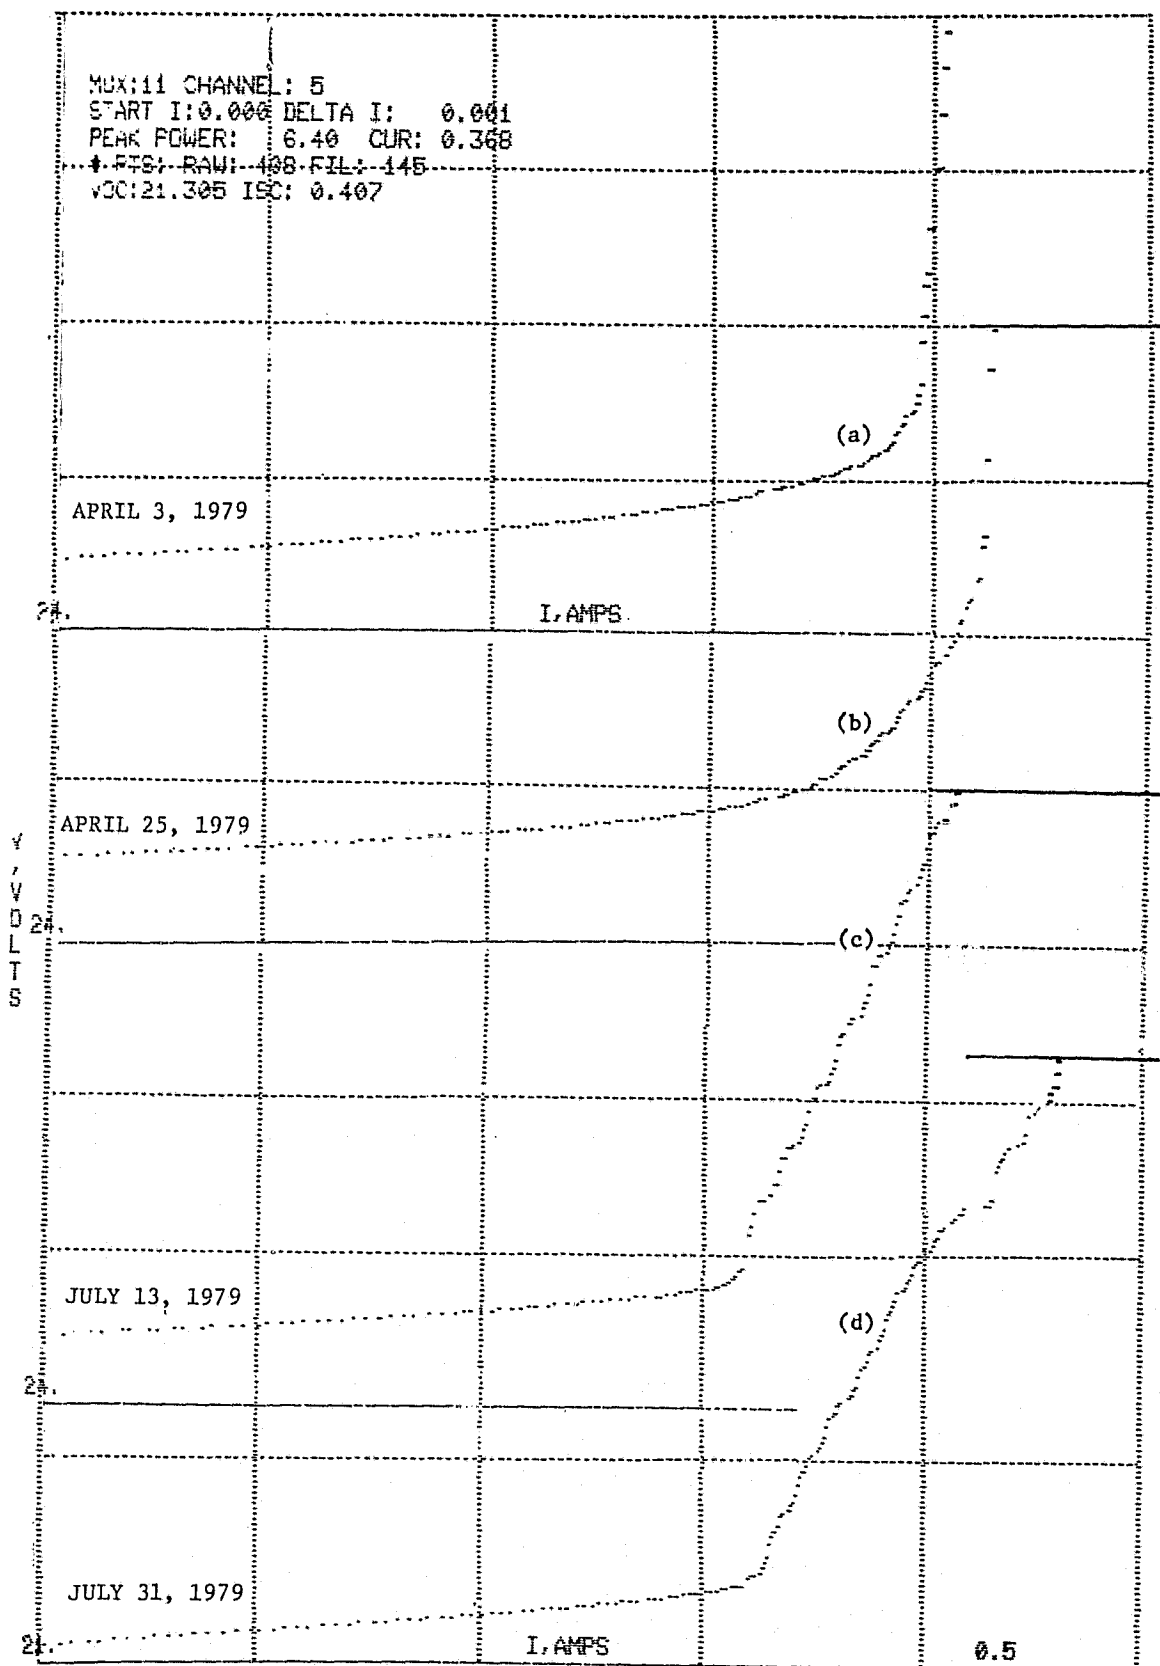
Figure 4-4. Evolution of I-V Degradation for a Module with an Impact Crack

have been observed. In March of last year there was a hail storm which cracked cells in many of the modules. One particular type of module, Sensor Tech Block II, was particularly vulnerable to the hail and experienced many cracks. An inspection performed by Quality Assurance indicated that each of 17 of these modules developed between one and five "impact" cracks, and 12 of the 17 modules later showed degraded I-V curves. The Solarex modules also experienced some hail damage but to a lesser extent. Figure 4-8 contains a photo of one of the impact cracks.

About a month after the hail storm, the I-V curves of the affected modules showed small fluctuations around the knee. The curves continued to change and the knees flattened out. Eventually the I-V curves assumed a stable degraded mode. The curves for module 165 are representative of those observed for the modules in this group. Figure 4-4 illustrates a progression of these curves over a few months. Twelve of the 24 degraded modules are of this family and all of these had I-V curves which resembled those shown in the figure.

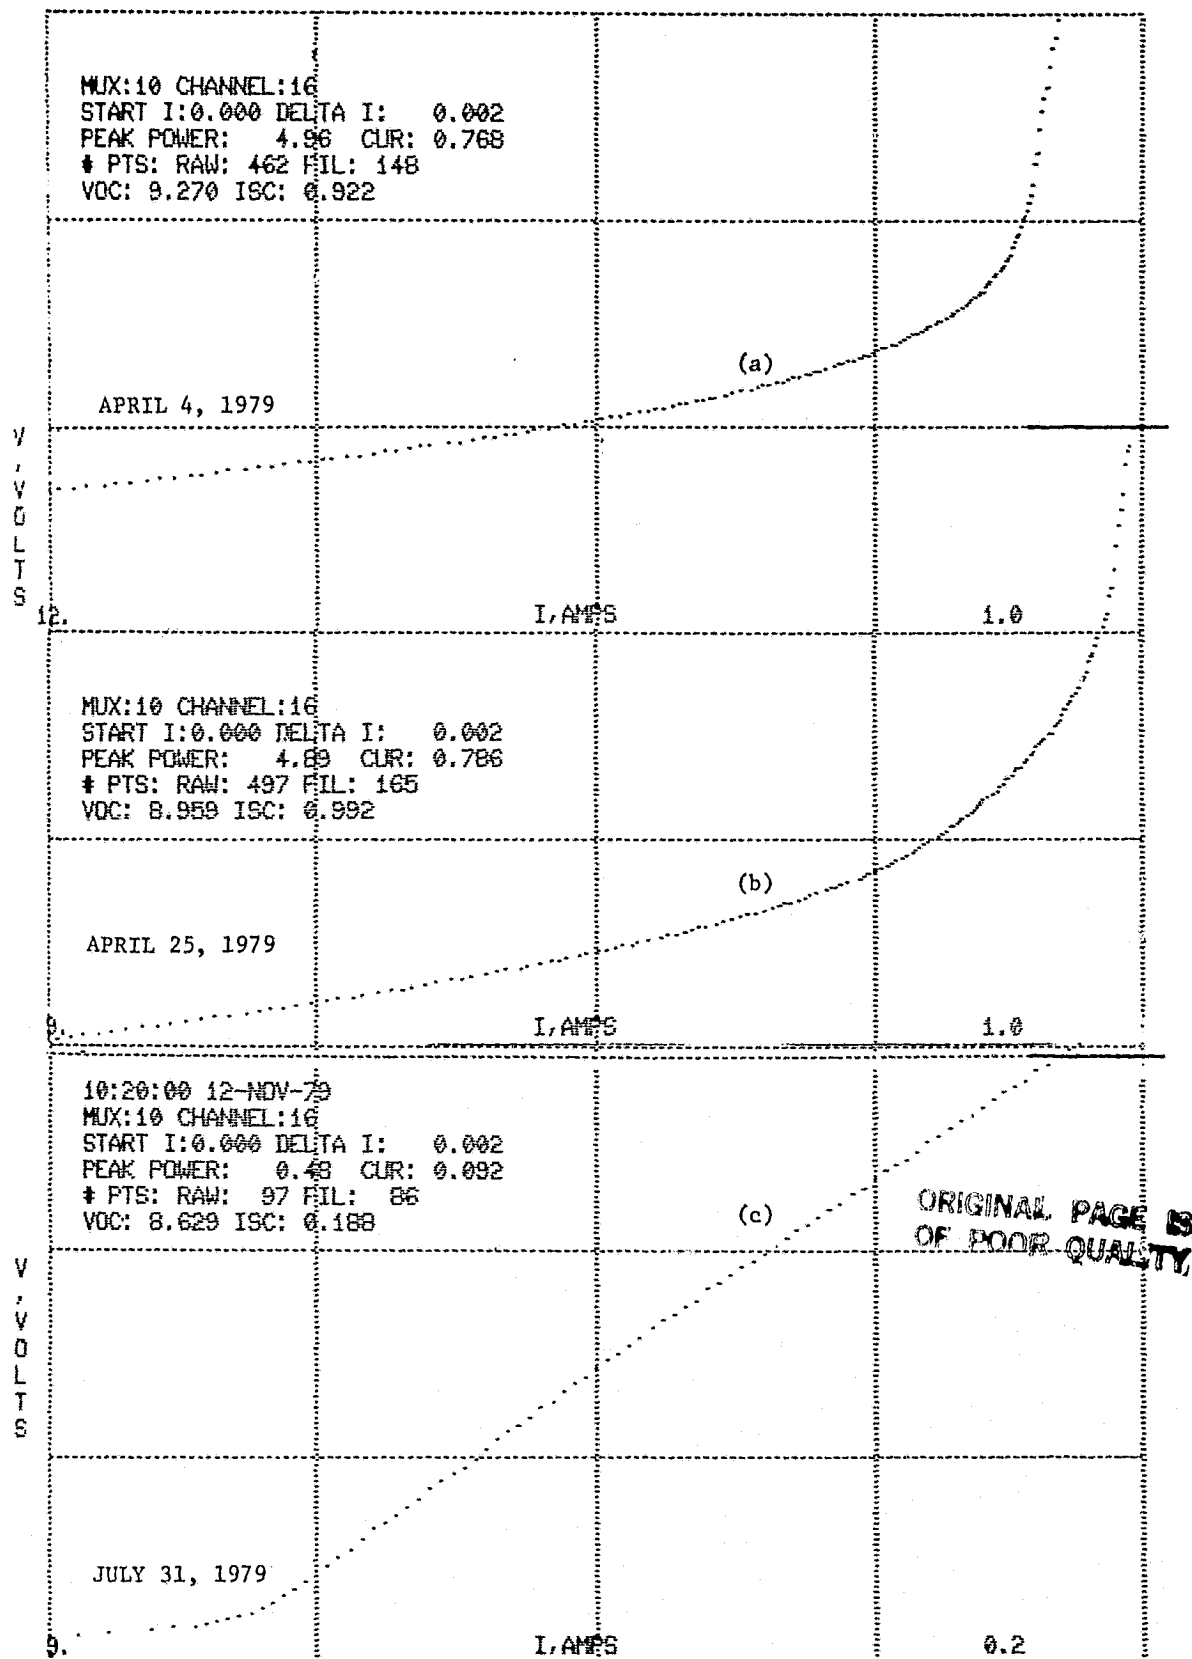
Figure 4-5. I-V History of Module with Cell in Reverse Bias

Case Study 4. The final case, that of module 160, is an interesting one in which there is a direct observable connection between the degraded I-V history and the appearance of a physical defect. One of the cells in this module developed so much heat as a consequence of operating in reverse bias that a portion of the cell was charred and a hole was burned through the encapsulant. A photograph of this area is shown in Figure 4-9. Several I-V curves at different times in this module's history are shown in Figure 4-5. The upper curve of April 10 shows the module to be operating normally. Two weeks later the first signs of degradation appeared, and by July 31 the module had degraded substantially. It appears to be getting worse and will probably fail completely.

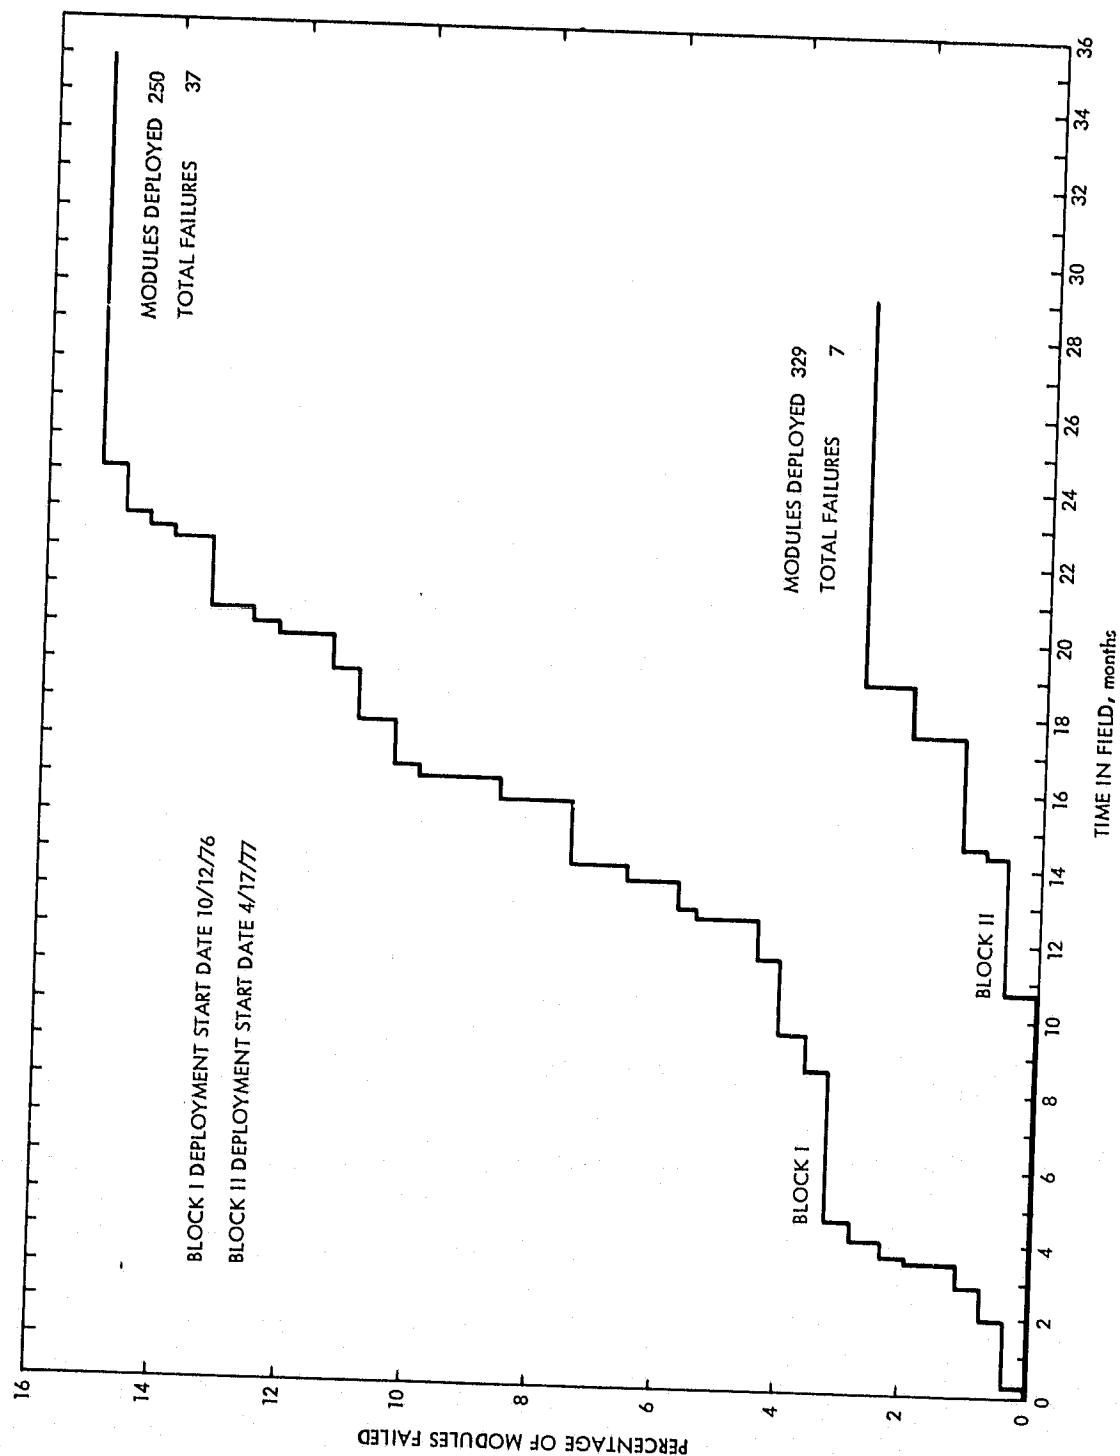
Figure 4-6. Failure Rates for Block I and Block II Modules from all Sites

A plot showing the failure rates for the Block I and Block II modules from all the sites is contained in Figure 4-6. The plot speaks for itself. After almost 2-1/2 years the failure rate of the Block II modules is only one-fifth that of the Block I modules. As can be seen in Table 4-1, no Block III modules have failed.

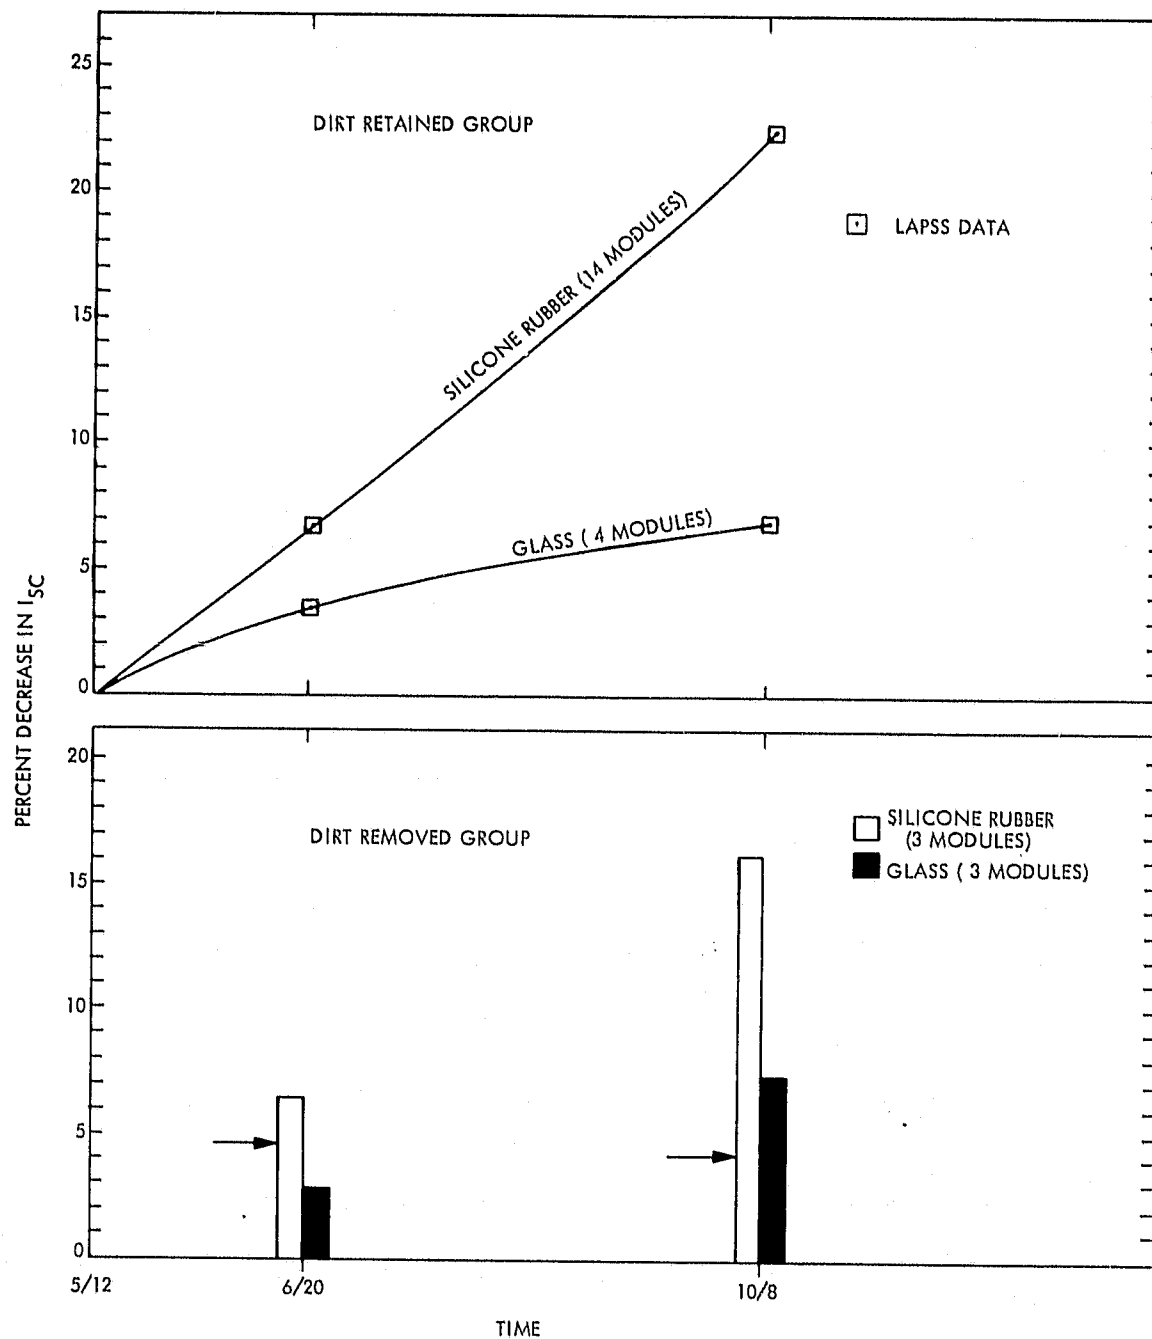
Figure 4-7. Results of Dirt Tests

placed in the field. On June 20 and October 8, both groups were removed and I-V data obtained. The "dirt retained" group was then replaced in the field while the "dirt removed" group went through an additional cycle of cleaning and LAPSS testing before going back into the field. Figure 4-7 contains the results*.

The silicone rubber "dirt retained" data on the upper graph shows a linear five percent per month decrease in transmittance due to dirt. A comparison of the silicone rubber data on the lower and upper curves also indicates that virtually all the dirt that fell on these modules was retained. In contrast, the glass module data exhibits

both a lower initial decrease than that of the silicone rubber and a tapering off of the accumulated effect. The difference between the levels of short-circuit current loss of glass and silicone rubber modules presented in the figure is substantial, and conflicts with data obtained during the previous year, which showed both types of modules losing about six percent per month. No explanation for the paradox is evident. A review of the data showed nothing unusual about either set. Another perplexing result was related to embedded dirt. The arrows adjacent to the silicone rubber data correspond to the average differences between the clean module data and the initial data of May 12. Prior to this date the silicone rubber modules went through a heavy-duty cleaning to remove as much of the embedded dirt as possible. According to the data, in the five week period after May 12 the modules acquired a new four percent embedded dirt layer which essentially did not change throughout the rest of the five month test. Perhaps in the process of cleaning the modules the surface was made receptive to acquiring this new layer.

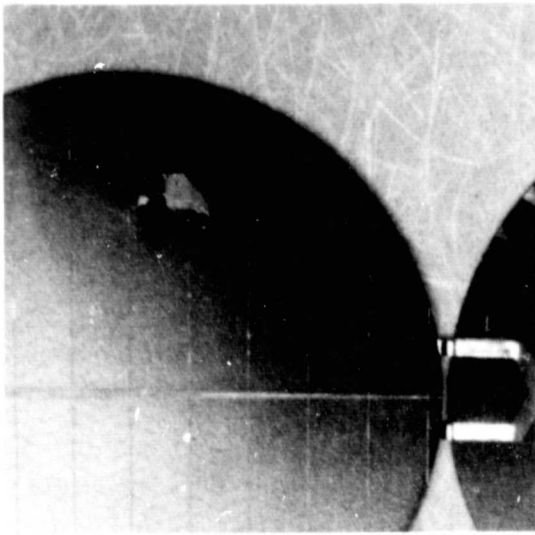
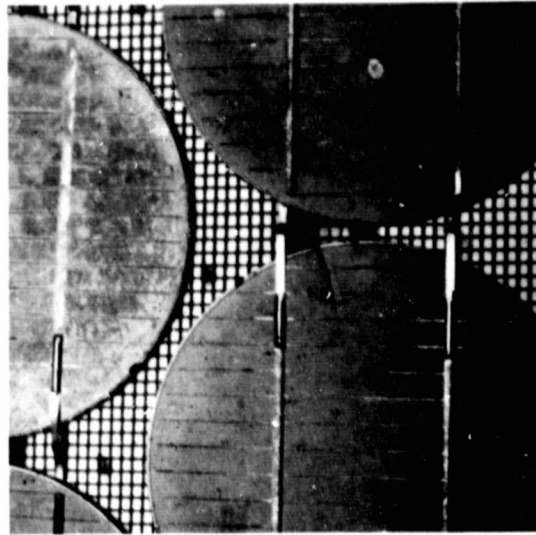
Impact cracks at the JPL site, probably caused by hail

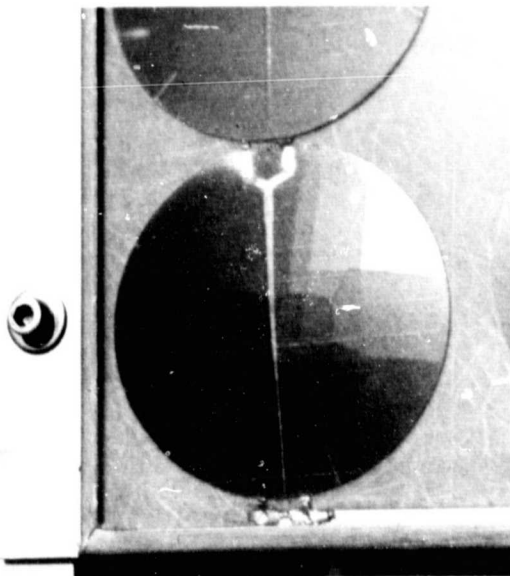
Cracked and bowed cell

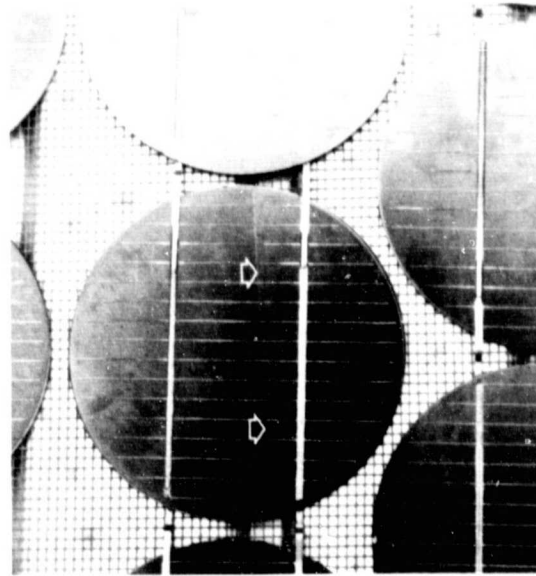
Typical rim-to-rim crack

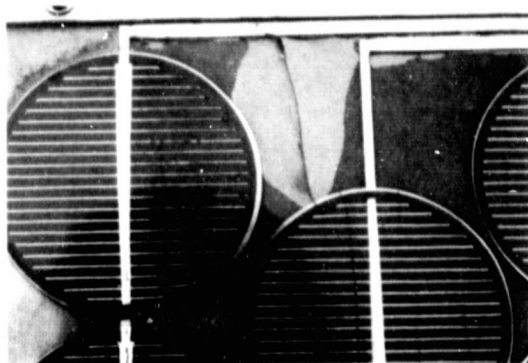
Encapsulant delamination

Block I module delamination. Much less delamination was observed with Block II and Block III modules.

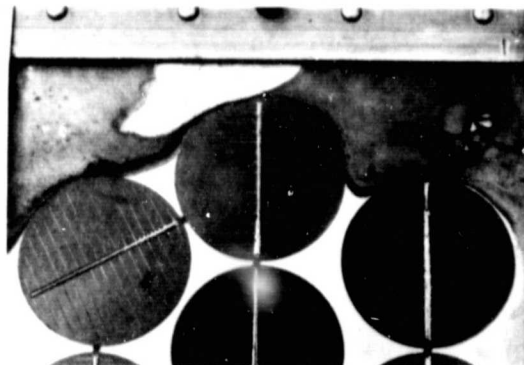
Dirt between substrate and encapsulant

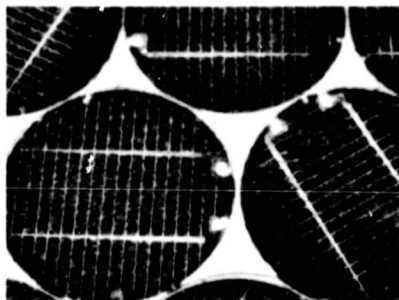
Bubbles in encapsulant.
Cover material is glass.

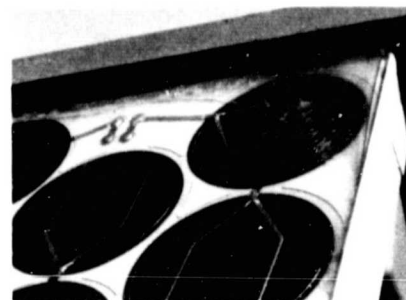
Encapsulant peeling away from cell and substrate (Houghton). Less severe examples of this type of delamination were observed elsewhere.

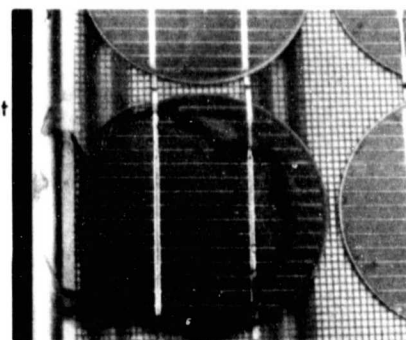
Cracked glass superstrate. Although the glass has been cracked for some time, the integrity of the module remains intact.

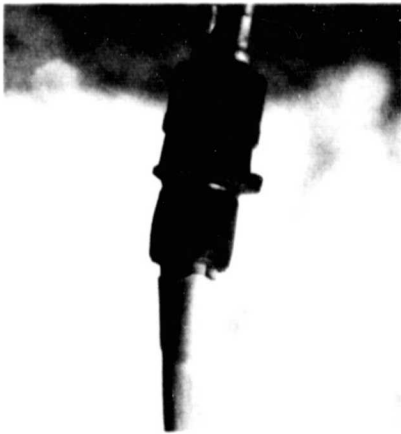
Deterioration of electrical connector

In general, wiring and connectors were in good condition. They were more susceptible to deterioration in dry, cold, or corrosive environments such as Dugway.

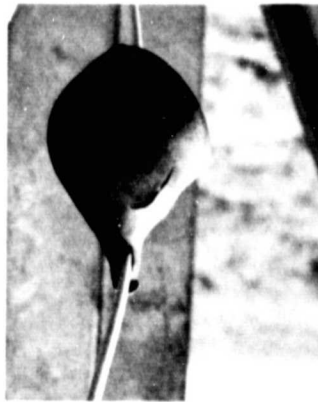
Deterioration of wiring protective boot

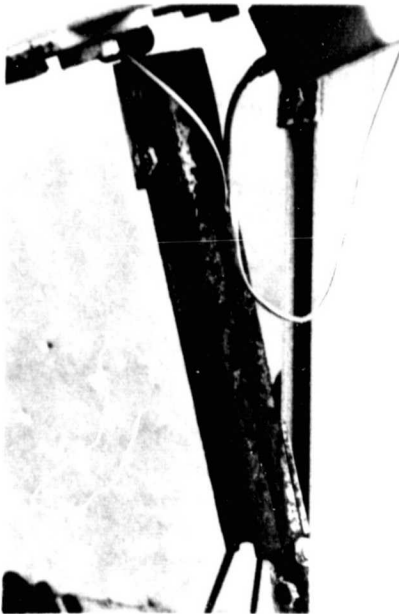
Stands at the continental sites are made from galvanized Unistrut material. Module frames did not show similar signs of corrosion, however some of the peripheral bolts and nuts did.

▲ Corrosion on stands at Key West after 22 months in field

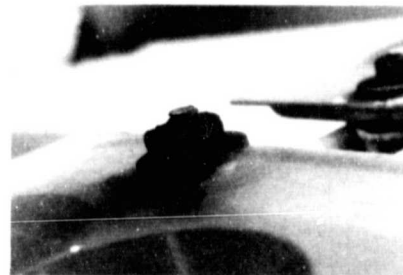
Hardware corrosion at Key West

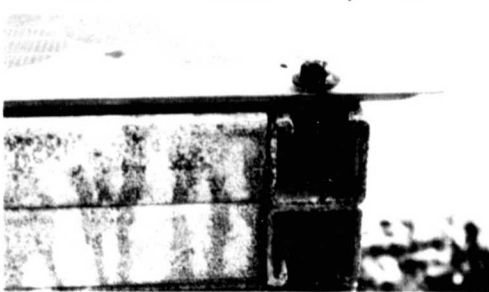
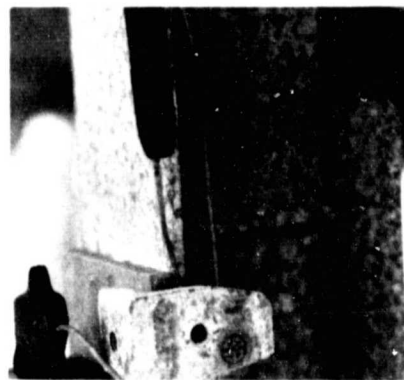
Corrosion on stand at Pt. Vicente after 14 months in field. Stands are constructed of galvanized steel.

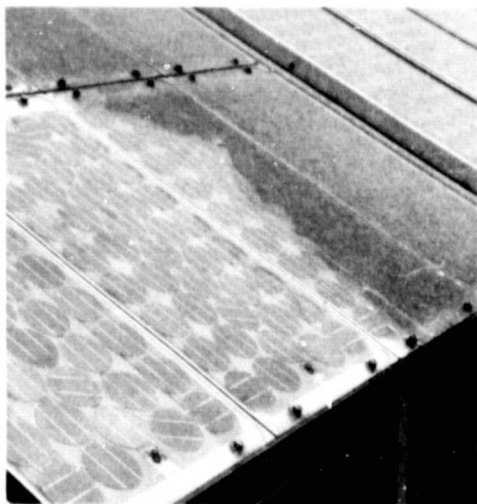
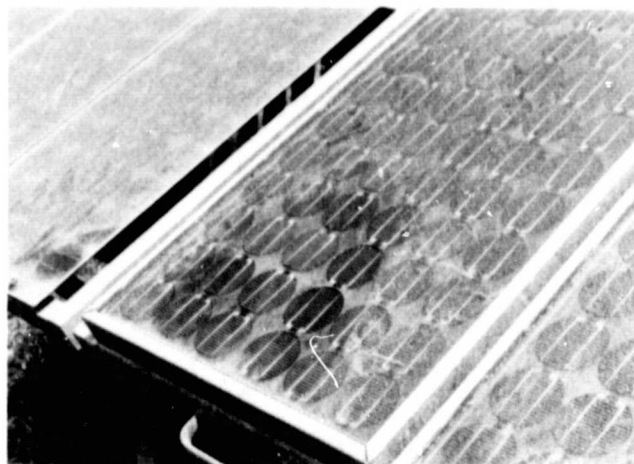
Silicone rubber modules

Glass modules

Eleven months of accumulated dirt at Pt. Vicente. Portions of the modules have been wiped clean.

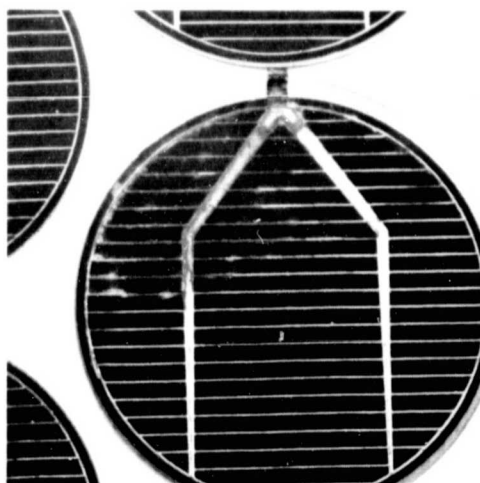
Conductor corrosion. A considerable amount of this was observed, possibly the result of inadequate flux removal during fabrication.

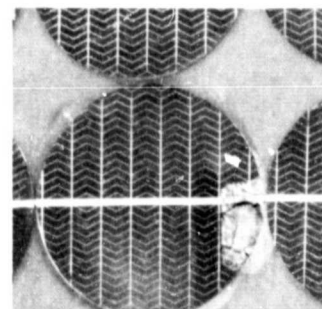
Burned cell and encapsulant. Cell undoubtedly was operating in reverse bias.

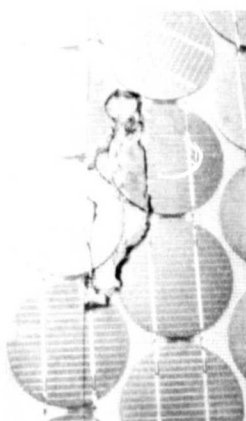
Module damage by vandalism at New Orleans (module still functioning).
